Failure of PVC Erosion Control Mat

By Johnny Cheung

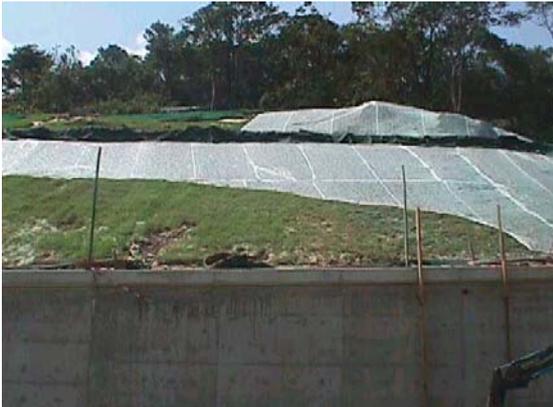
Figure 2: Slope with poor vegetation coverage

Basically, PVC ECM can only protect soil slope surface with gradient not greater than 60°. To have landscape improvement on slope surface after the installation of the PVC ECM, hydroseeding is usually applied on the surface of PVC ECM. However, good coverage of healthy vegetation can hardly be achieved (figures 2 & 3).

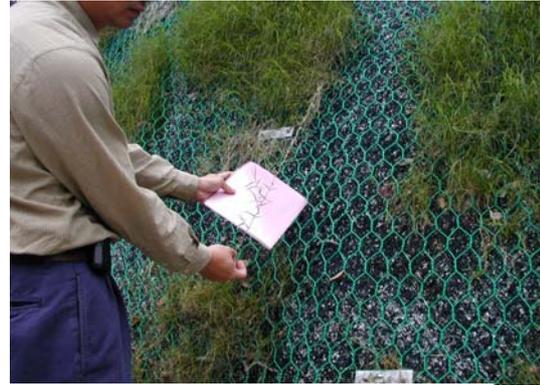
Figure 4: Unhealthy Stolon

1. In general, the PVC ECM is about 20mm to 30mm thick and its closely-knitted texture holes less than 10 mm. Thus, the stolon from grass root cannot reach the soil surface due to the obstruction caused by PVC ECM. The stolon continues to extend without developing its rooting system. Under such circumstance, a stolon can grow more than 1m long but that is not a healthy state (Figure 3). Eventually, the grass will die due to insufficient nutrients and water.

-Use of biodegradable ECM: Coir mesh and Coir Log.

-Avoid using PVC ECM on slope surface

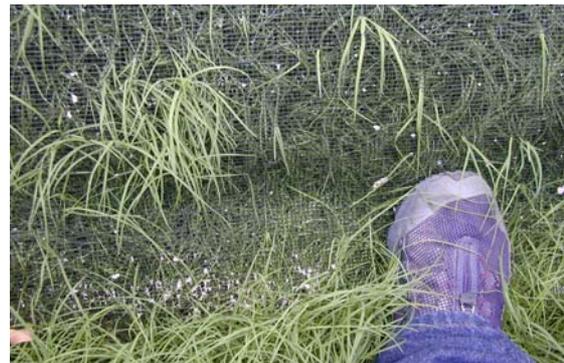
Figure 5: Trapped Grass

2. Due to the small holes of PVC ECM and improper workmanship, part of the PVC ECM cannot be tightly installed on the irregular slope surface. Thus, grass is trapped under the mat and the temperature inside rises because of the dead grass (figure5).

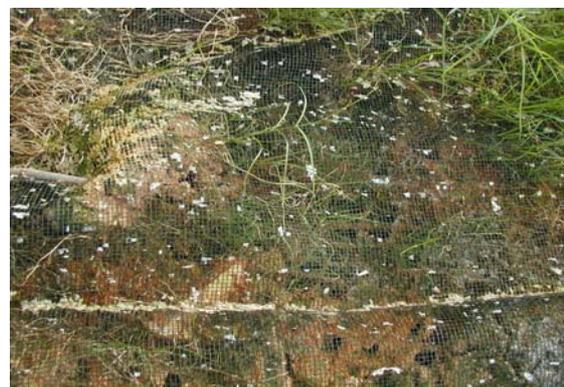
Figure 6: Seeds, mulch & fertilizer cannot reach soil

3. Since most of the seed, mulch and fertilizer of the hydroseeding material cannot penetrate into the PVC ECM and reach the soil surface, the grass cannot develop its roots properly.
