<p>Project: Contract No. GE/2005/39 10 Year Extended Landslip Preventive Measures Project, Phase 4, Package H Feature No. 11NW-D/C76, Junction of Shun Yung Street and Fat Kwong Street</p>

<p><b>TOYO GREENLAND CO., LTD.</b></p>
<p>Drawing Title: Typical Detail of Installation of Eco-Bags On the Top Surface &amp; below the Bottom Surface of Protruded Soil Nail Head</p>	
<p>Check : Ho Tat Pui, Daniel</p>	<p>Scale : N.T.S.</p>
<p>Ref.: C1597/07/TGD0003 - Sketch (i)</p>	<p>Date: 22 January 2007</p>

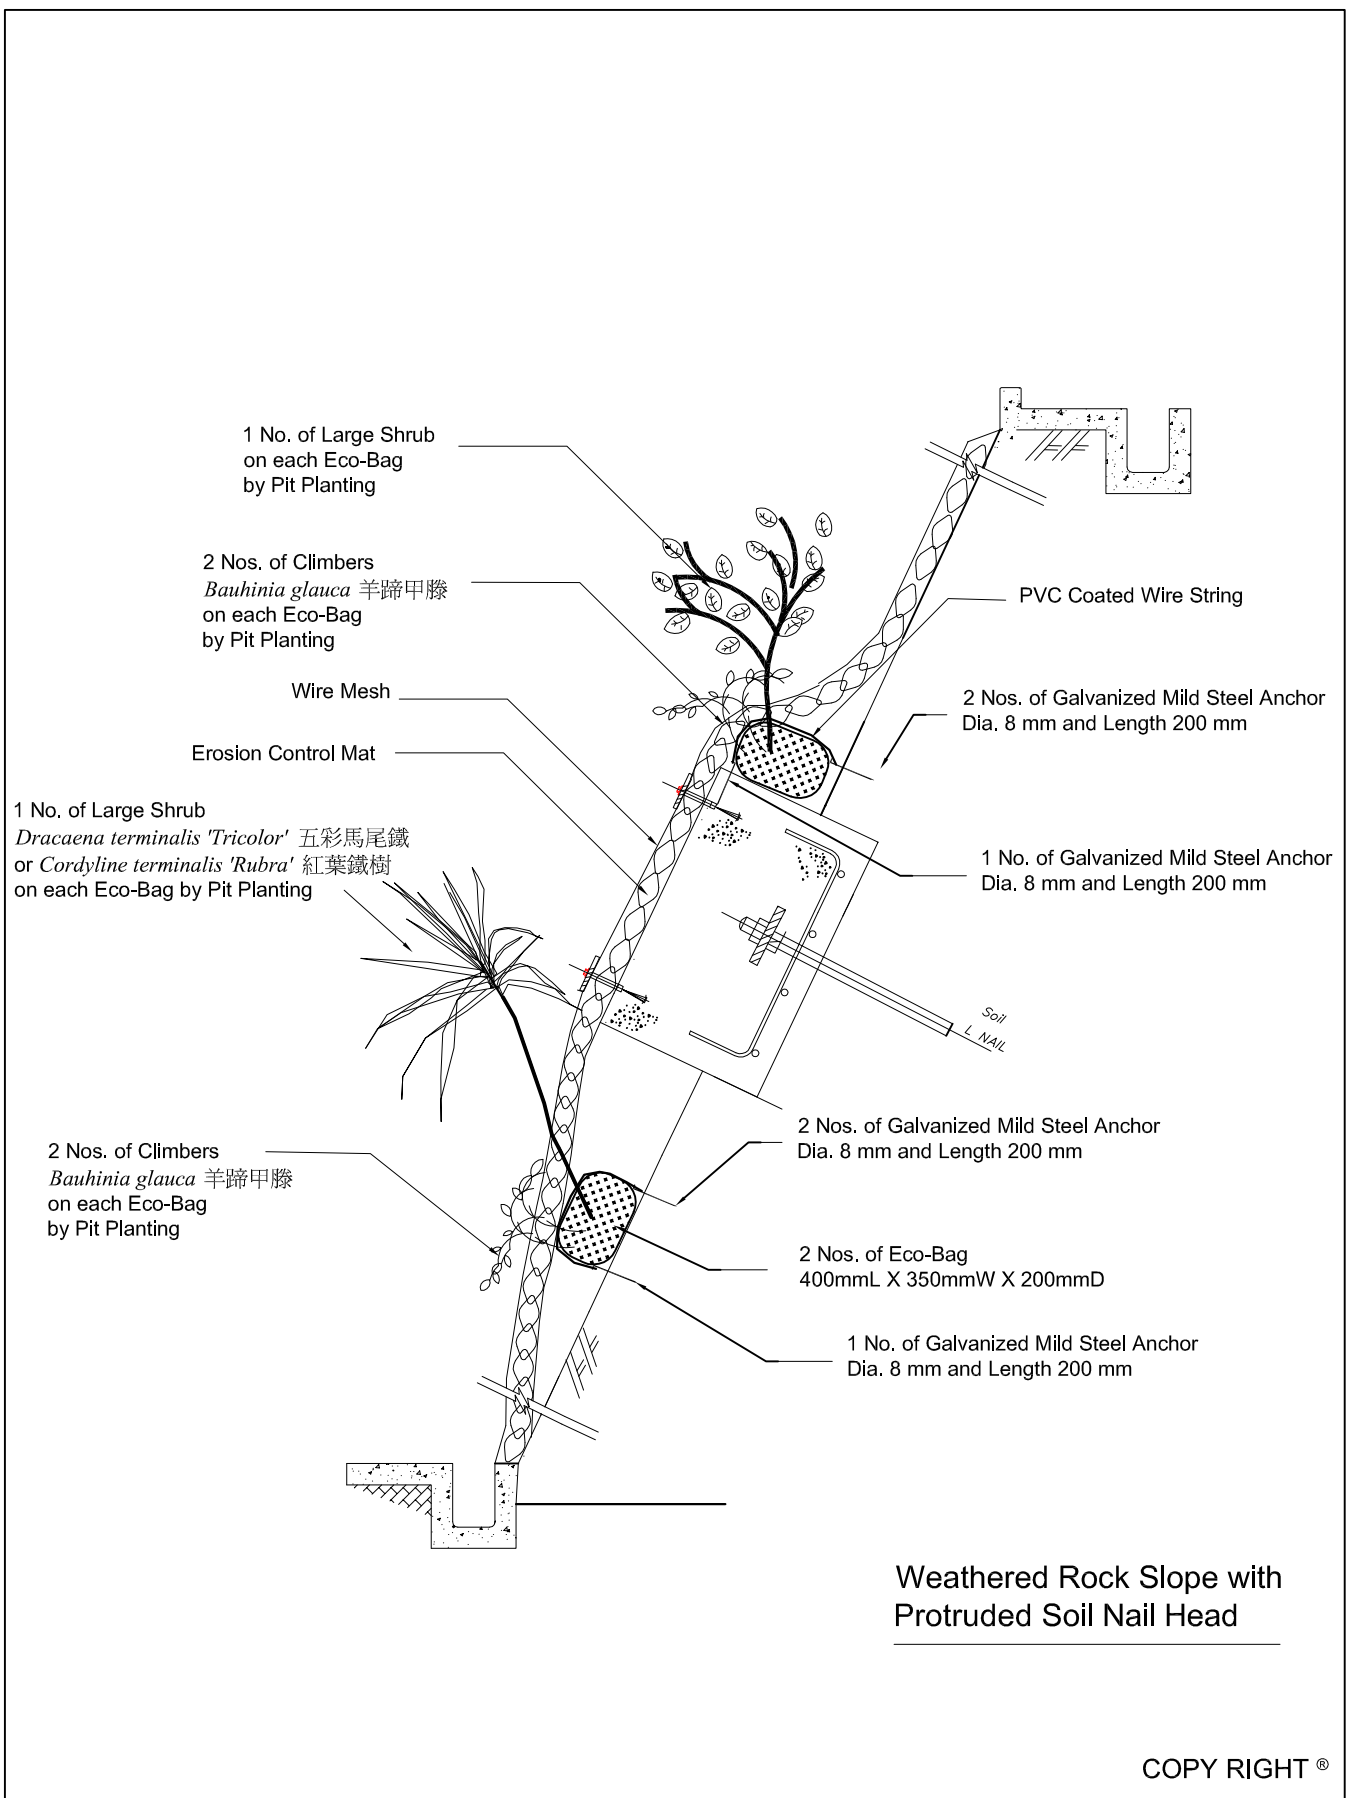
**Weathered Rock Slope with  
Protruded Soil Nail Head**
