Establishment of Ecosystem in Sai Tso Wan Landfill

Eco-Green System

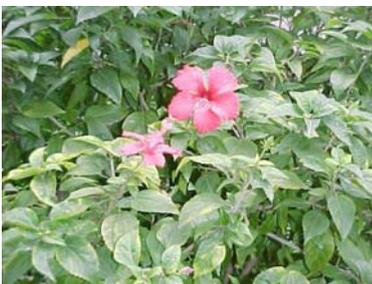
Hibiscus rosa-sinensis (大紅花)

After the sprigging of *Wedelia*, shrubs have been planted, they are : *Gordonia axillaris* (大頭茶), *Melastoma sanguineum* (毛稔), *Mussaenda pubescens* (玉葉金花), *Rhaphiolepis indica* (車輪梅), *Rhododendron simsii* (紅杜鵑), *Rhodomyrtus tomentosa* (桃金娘) and *Hibiscus rosa-sinensis* (大紅花). Throughout the year, it was really amazing to find most shrubs flowered on the slope in different periods of time. Moreover, although their growing rate varies, all the shrubs have adapted the new environment

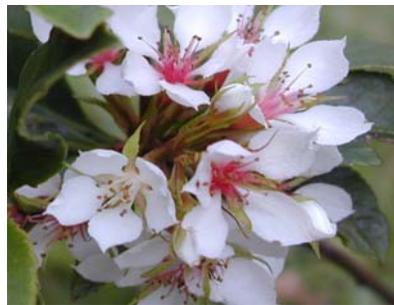
Rhaphiolepis indica (車輪梅)

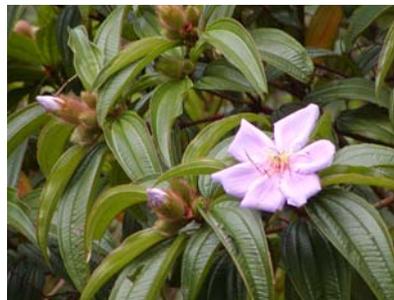
Melastoma sanguineum (毛稔)

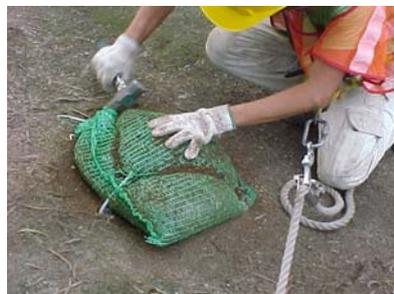
Fixing of Eco-bag on the shotcrete slope provide additional nutrients for shrubs planted

In addition to the current techniques such as Hydromulching system and Toyo-Mulching System, Eco-Green System made use of extra Eco-bag filled with soil mix fixed on the slope before the installation of 3-dimensional wire mesh with fertilizer strips. On the

Such amount of nutrients was initially sufficient not only for grass seed to germinate but also for climbing ground cover to grow and develop; however, for shrubs, the amount was not adequate for their growth. Thus, the application of Eco-bag provides more nutrients and support for the shrubs planted to enlarge the greening effect on the closed landfill.

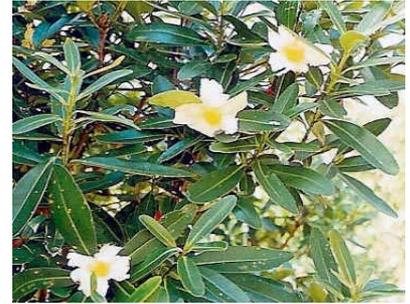
Gordonia axillaries (大頭茶)

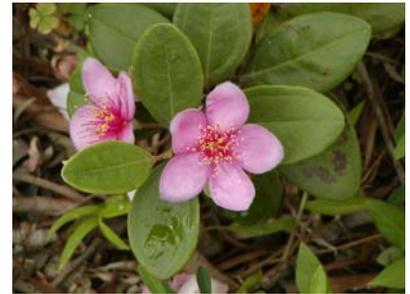
Rhodomyrtus tomentosa (桃金娘)

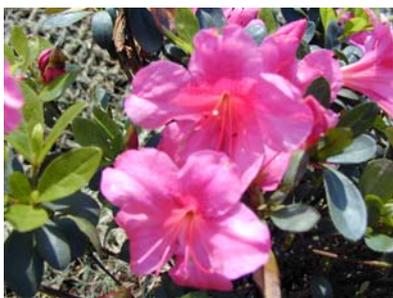
Rhododendron simsii (紅杜鵑)

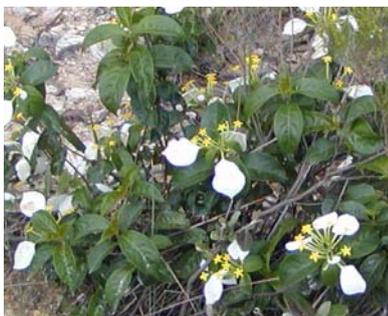
Mussaenda pubescens (玉葉金花)

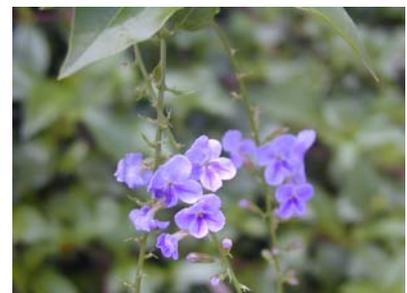
Invaded plant species –

Duranta repens (假連翹) with purple flowers

Under Eco-Green System, diverse vegetation species including grass, climbers and shrubs maintained self-sustained nutrients cycle after the establishment period. On the other hand, with the suitable planting fiber soil, new plant species such as *Duranta repens* (假連翹) and *Lantana camera* (馬纓丹) have invaded into the captioned slope showing other

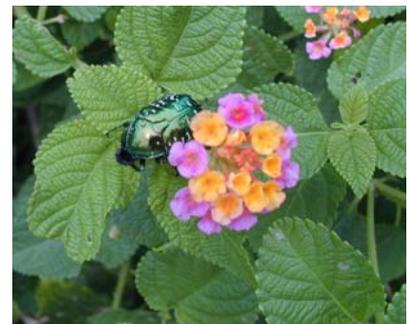
Invaded plant species –

Lantana camera (馬纓丹) with an insects
